Fitting Suggestions for HoseSource™ Hose & Tubing

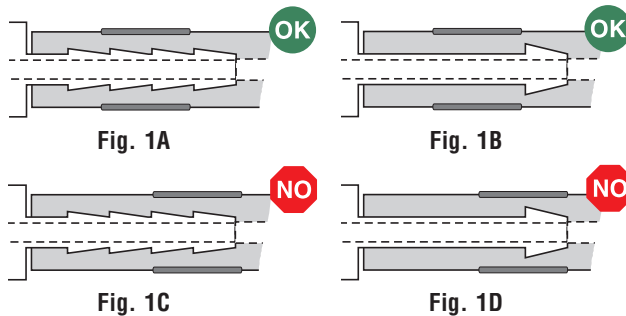
Clamps over barbed fittings

In the illustrations above, the clamps are properly positioned in Figure 1A and 1B, directly over the middle barbs and behind the first barb. This is extremely important in the case of single-barb fittings, as shown in Figure 1B, since the barb is generally much larger than the shank of the fitting. The compressed material cannot pass over the barb when under tension, thus securely holding the fitting to the hose.

In Figures 1C and 1D, the clamp has been improperly positioned too close to the end of the fitting. In Figure 1C, only the barb nearest the end of the fitting is effective in maintaining fitting retention. The first two barbs serve no purpose whatsoever in providing fitting retention or leak resistance. In Fig. 1D, the situation is even worse, since the clamp can very easily cut the core tube over the enlarged barb, leading to leakage and subsequent cover blisters or bursts.

When choosing multi-barb fittings for use with *HoseSource*™ hose, as in Fig. 1A and 1C, it is important that the barbs not be too deep. The core tubes in *HoseSource* hoses are generally somewhat harder than conventional rubber tubes and therefore the material cannot flow into the deep barb, as it would with a soft rubber compound.

In addition to the properly installed fittings shown in Fig. 1A, 1B, 2A and 2B above, we also suggest the use of a two-barb clamped fitting when high pressures are involved.

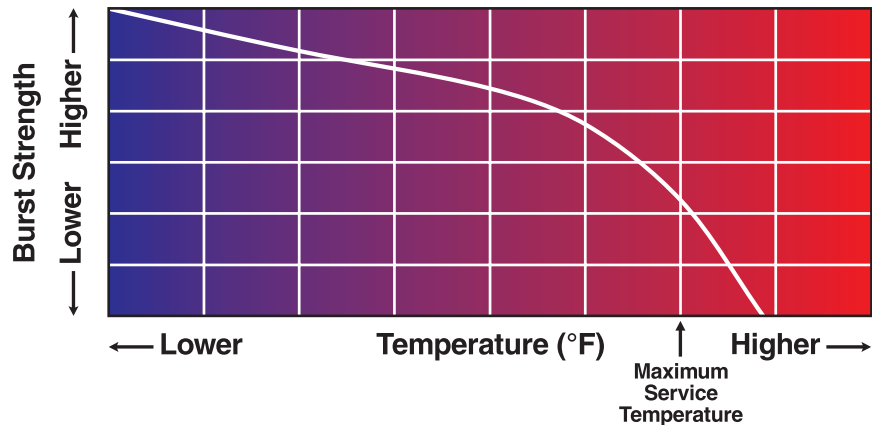
Burst strength decreases as temperature increases

As a general rule, the working pressure ratings for plastic reinforced hoses are based on room temperature conditions. The maximum allowable pressure for a hose decreases as the temperature increases and the material becomes softer and more elastic. Fitting retention decreases at higher temperatures as the compression on the material declines.

Working pressure ratings can be affected significantly by the type of fitting used, the method of attachment, and the temperature to which the hose assembly is exposed in service. Repeated intermittent periods of exposure to elevated temperatures can affect fitting retention and it is, therefore, very difficult to assign working pressure ratings at high temperatures. The graph below demonstrates the overall trend.

Working pressure ratings are given in this catalog at 70°F and 122°F. Between 122°F and the maximum service temperature, it must be noted that a rapid decline in the pressure rating of the hose may occur, and all factors relating to the hose, fittings and service conditions must be taken into consideration.
